## Executive Summary

This work presents a UAV-enabled computer vision framework for automated roof damage detection, designed to improve the speed, safety, and consistency of post-storm inspections. The system identifies both hail and wind damage using aerial imagery and addresses a key barrier in the field by combining fragmented roofing datasets into a standardized multi-class dataset of over 10,000 labeled images. To enhance detection of small and subtle damage features, the framework incorporates a SAHI-inspired slicing strategy. The approach delivered a marked increase in detection accuracy, raising mean average precision from 0.35 to 0.65. Overall, the findings demonstrate strong potential for deployment in insurance and property assessment workflows, where faster inspections and more efficient claims handling are critical.

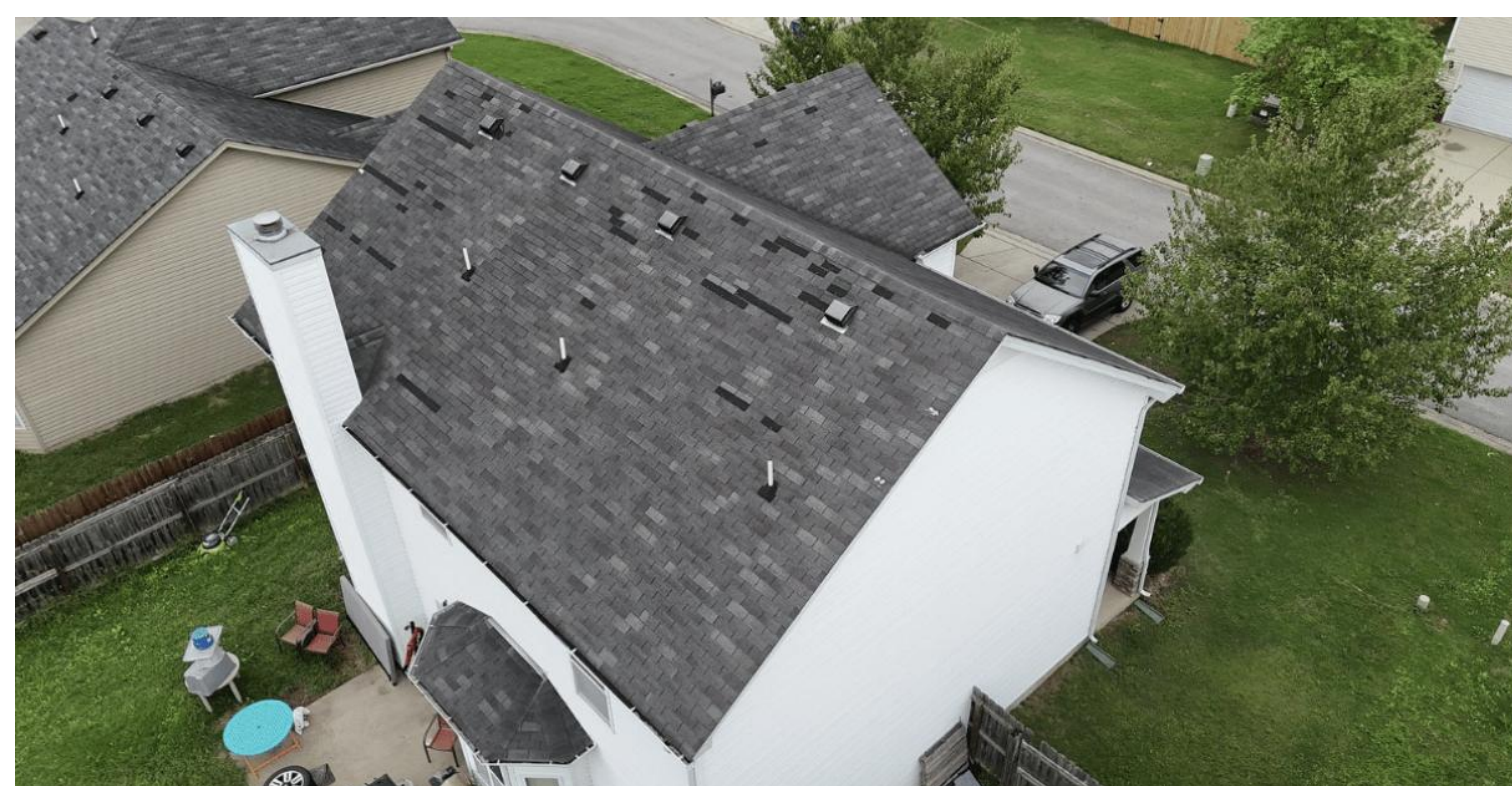
Figure 1. UAV-captured image of a residential roof showing missing shingles caused by wind damage. [5]

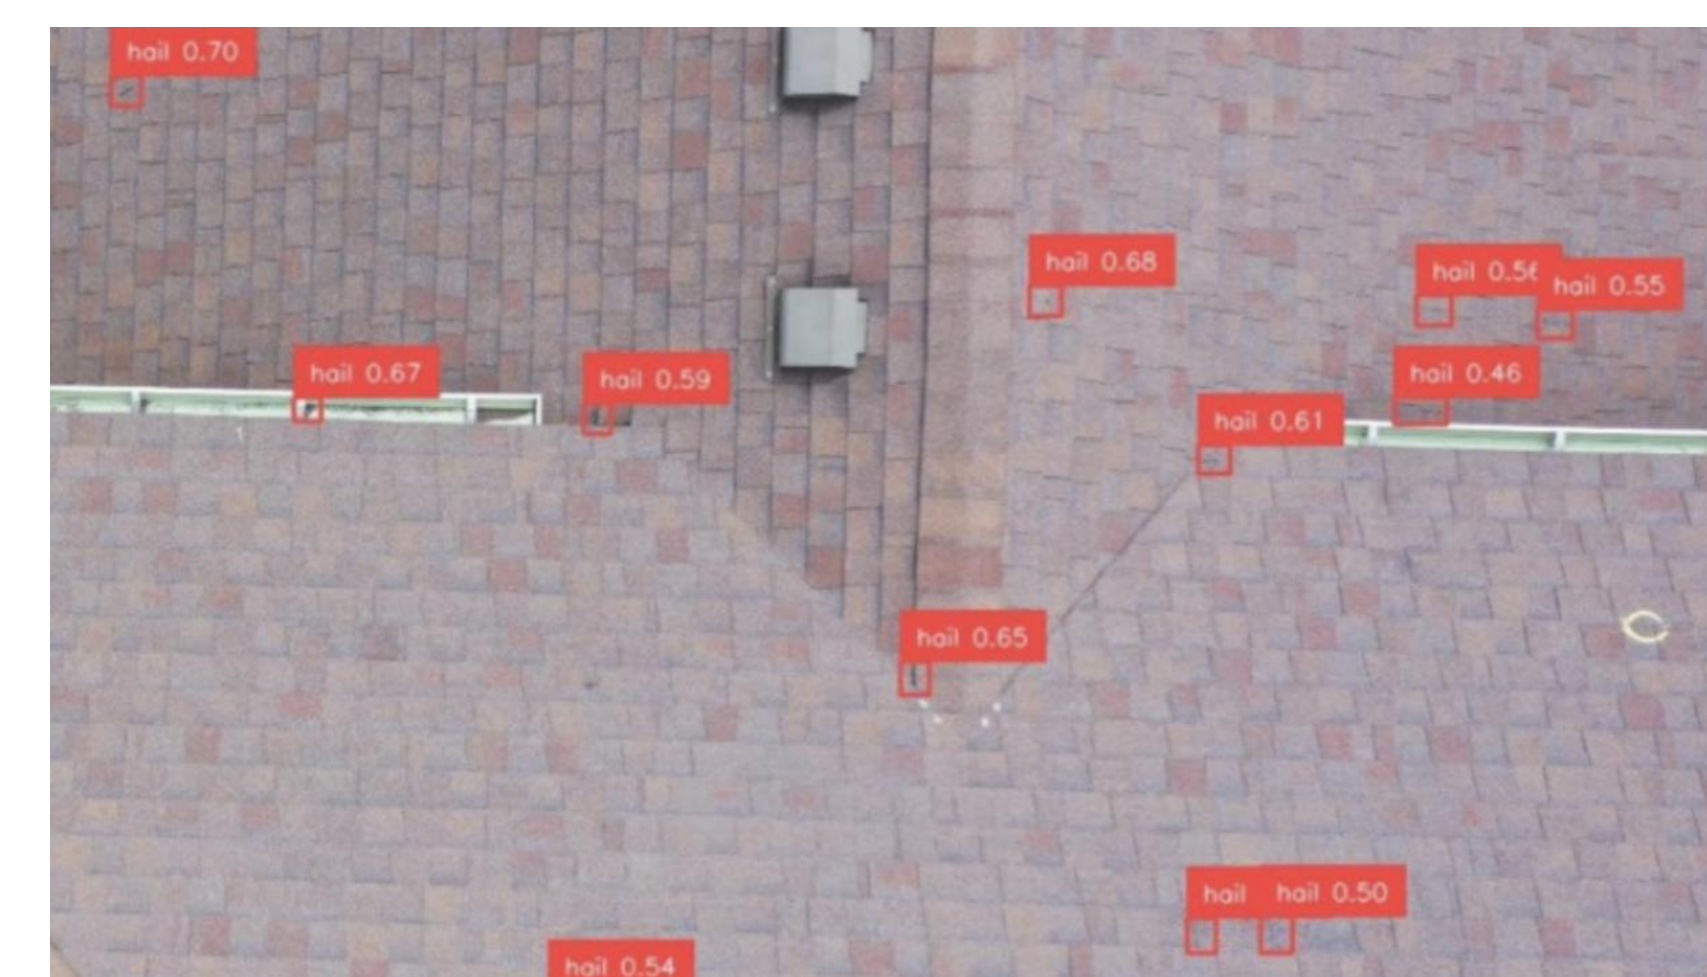
Figure 3. Top-down UAV image of a residential roof with hail damage detections from our model, shown as red bounding boxes with confidence scores [3]

The baseline model achieved a mAP@50 of 0.35. After applying the unified dataset design and SAHI-inspired slicing strategy, the fine-tuned RF-DETR model achieved a mAP@50 of 0.65. This improvement indicates that the proposed preprocessing approach helped the model better detect roof damage, particularly small and subtle patterns such as hail impacts. These results show that dataset structure and image scale played a significant role in detection performance. Overall, the proposed method improved automated roof damage detection and demonstrated the value of combining dataset unification with localized image slicing for UAV-based inspection.
